DEPARTMENT OF TRANSPORTATION

Contract #: 04-0120F4Cty: SF/ALA Rte: 80 PM: 13.2/13.9File #: 69.28**WELDING INSPECTION REPORT****Resident Engineer:** Pursell, Gary**Address:** 333 Burma Road**City:** Oakland, CA 94607**Report No:** WIR-010393**Date Inspected:** 09-Nov-2009**Project Name:** SAS Superstructure**OSM Arrival Time:** 700**Prime Contractor:** American Bridge/Fluor Enterprises, a JV**OSM Departure Time:** 1900**Contractor:** Zhenhua Port Machinery Company, Ltd (ZPMC), Changxing Island **Location:** Shanghai, China**CWI Name:** Chen Xi**CWI Present:** Yes No**Inspected CWI report:** Yes No N/A**Rod Oven in Use:** Yes No N/A**Electrode to specification:** Yes No N/A**Weld Procedures Followed:** Yes No N/A**Qualified Welders:** Yes No N/A**Verified Joint Fit-up:** Yes No N/A**Approved Drawings:** Yes No N/A**Approved WPS:** Yes No N/A**Delayed / Cancelled:** Yes No N/A**Bridge No:** 34-0006**Component:** OBG Crossbeams and components**Summary of Items Observed:**

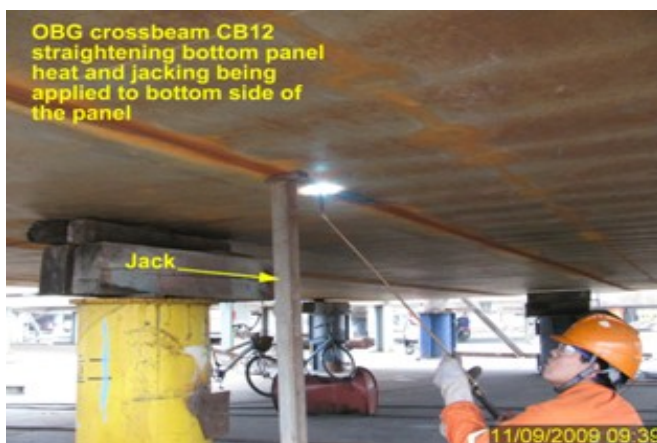
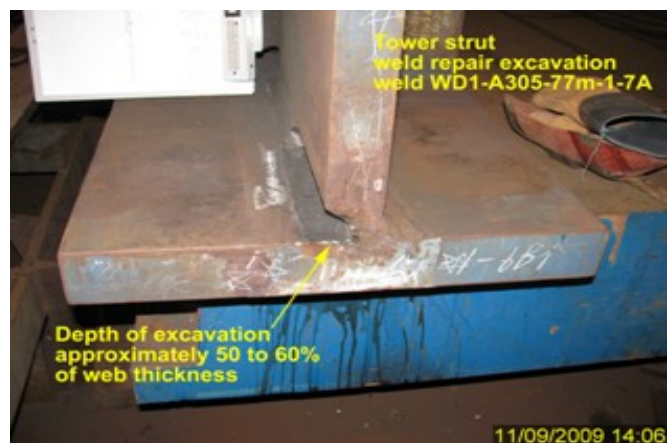
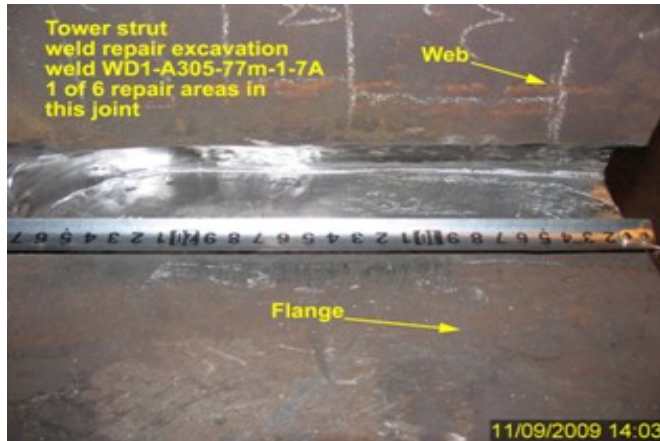
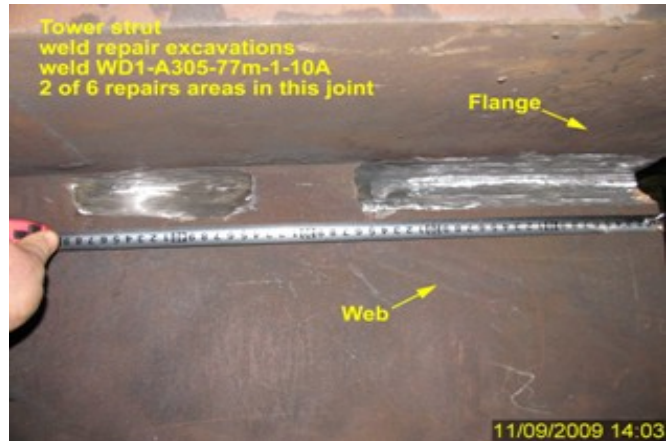
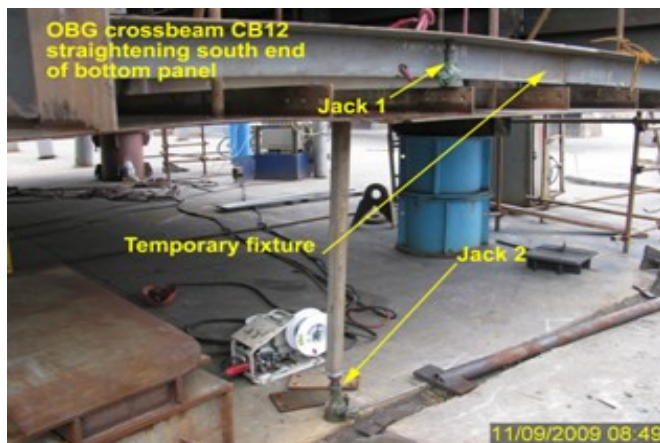
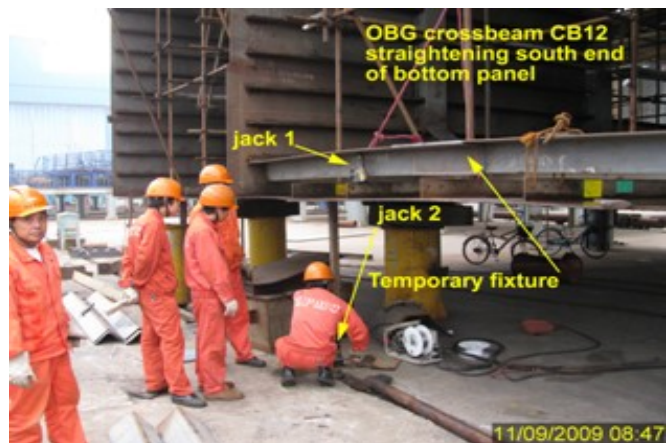
OBG CROSS BEAM CB12

This QA observed ZPMC personnel flame straightening the SPCM bottom panel on the south end of this crossbeam. The workers were observed using a temporary formed angle fixture stretched across the end of the crossbeam, hooked underneath a stiffener on the east side panel and one of the stiffeners on the intermediate panel, with a jack near the center of the angle to secure and support the top side of the panel. Another jack with a steel square tubing extension was used to apply pressure to the underside of the panel. The workers then commenced applying heat to approximately 500mm of bottom panel weld joint CB201C-012-002. This procedure appeared to be in general compliance with the approved written procedure on site identified as HSR-(B)-0328. See attached photos for details.
